Periodic Inspections of Kahului and Laupahoehoe Breakwaters, Hawaii

Armor Unit Monitoring for Period 1992/93-2001

Robert R. Bottin, Jr., and Daniel T. Meyers

August 2002

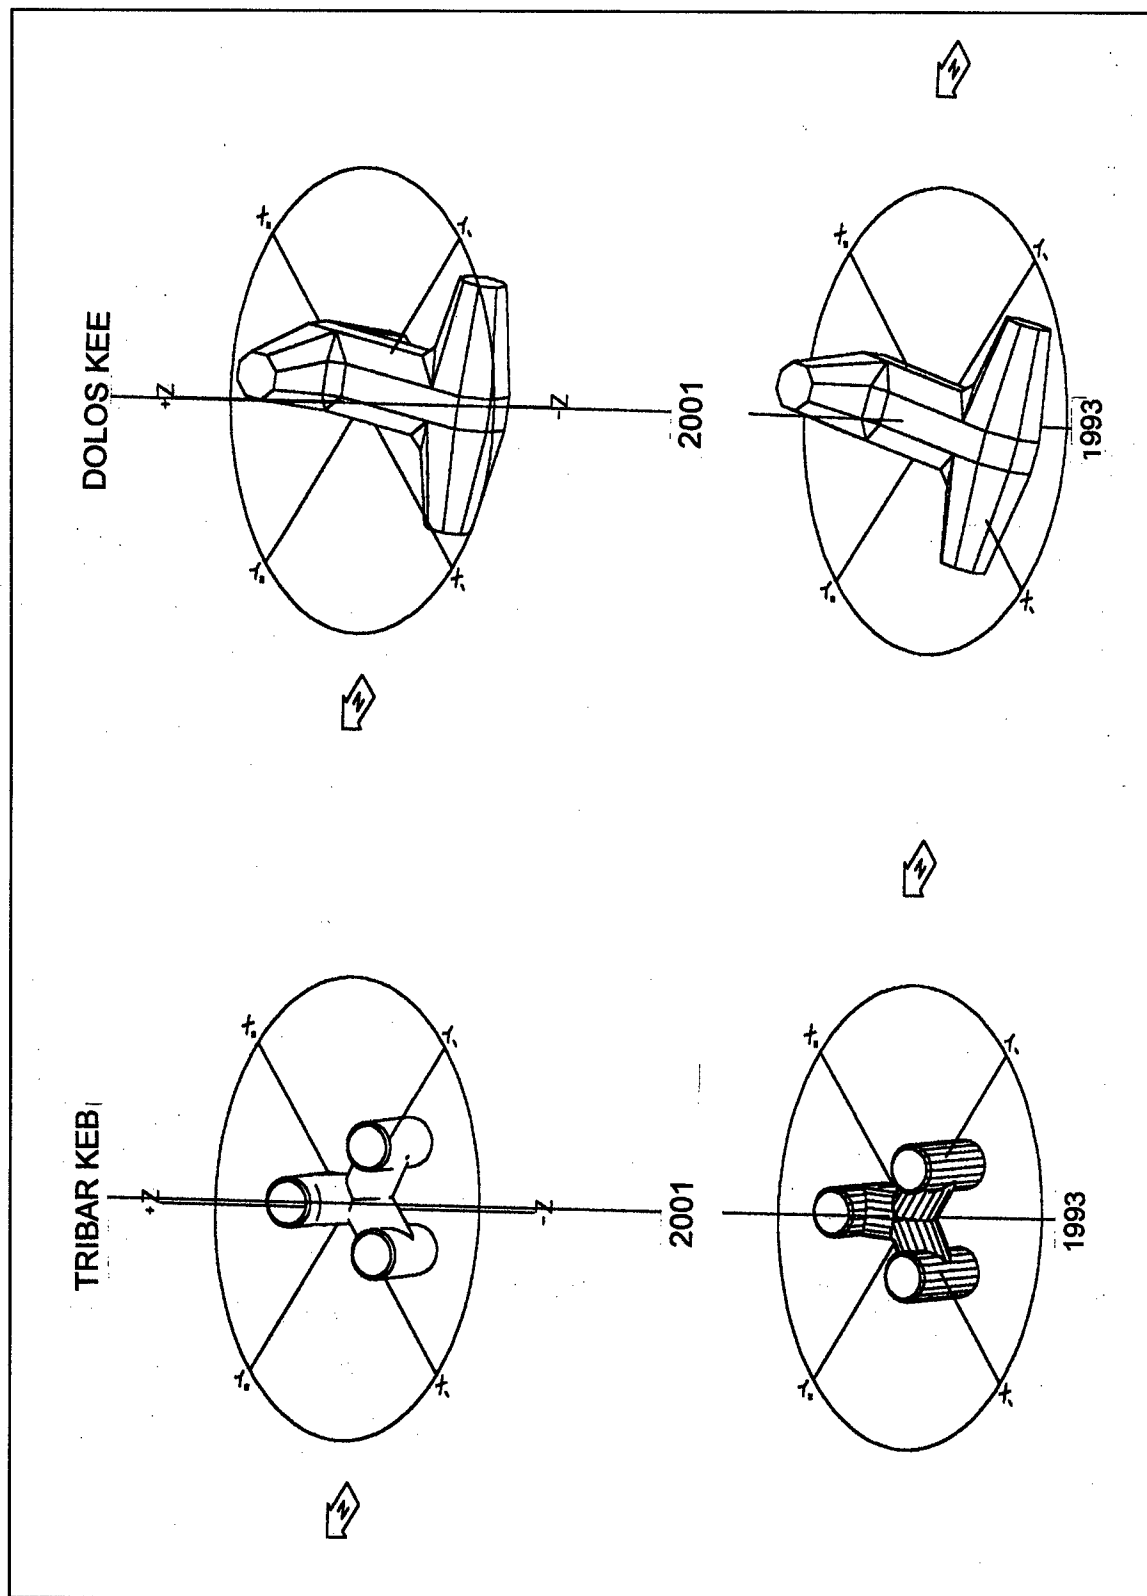
With the x, y, and z (easting, northing, and el) coordinates defined for each target on the various armor units, the coordinates of the centroid (center of mass) of each targeted armor unit were computed for the 2001 aerial survey. In addition, the position of each armor unit relative to the x, y, and z axes was determined and compared with previous data. Figure 22 shows, in three dimensions, the orientation and comparison of representative armor units to the three axes for the two surveys. The centroid coordinates of each targeted armor unit on the Kahului east and west breakwaters and the Laupahoehoe breakwater are shown in Tables 5-7 and compared with the aerial survey results of 1992/ 1993. Maximum movement of the centroids for the Kahului east breakwater was 0.536 m (1.76 ft) and 0.671 m (2.2 ft) in the horizontal and vertical directions, respectively, while average movements were 0.119 m (0.39 ft) and 0.17 m (0.57 ft) in the horizontal and vertical directions. As noted earlier, data were not obtained for two targets (KED1 and KEE2) on the Kahului east breakwater, however, based on information available and known dimensions of these armor units, their centroid positions were calculated. For the Kahului west breakwater, maximum horizontal and vertical centroid movements, respectively, were 0.64 m (2.1 ft) and 0.186 m (0.61 ft), while average movements were 0.113 (0.37 ft) and 0.64 m (0.21 ft) in the horizontal and vertical directions. Maximum movement of the centroids for the Laupahoehoe breakwater was 0.091 m (0.3 ft) and 0.085 m (0.28 ft) in the horizontal and vertical directions, respectively, while average movements were 0.03 m (0.1 ft) and 0.034 m (0.11 ft) in the horizontal and vertical directions. The targeted armor units' orientation (rotation angle relative to the x, y, and z axes) are presented in Tables 8-10 for the east and west Kahului breakwaters and the Laupahoehoe breakwater and compared with the aerial survey results of 1992/ 1993. For the Kahului east breakwater, changes in the rotation angle of the targeted armor units varied from 0.03 to 24.57 deg with an average of 3.09 deg. Changes in rotation angles varied from 0.0 to 17.32 deg for the Kahului west breakwater with an average of 2.02 deg. For the Laupahoehoe breakwater, changes in rotation angles varied from 0.01 to 0.36 deg with an average of 0.1 deg.

Figure 22. Comparison of representative targeted armor unit position relative to x, y, and z axes

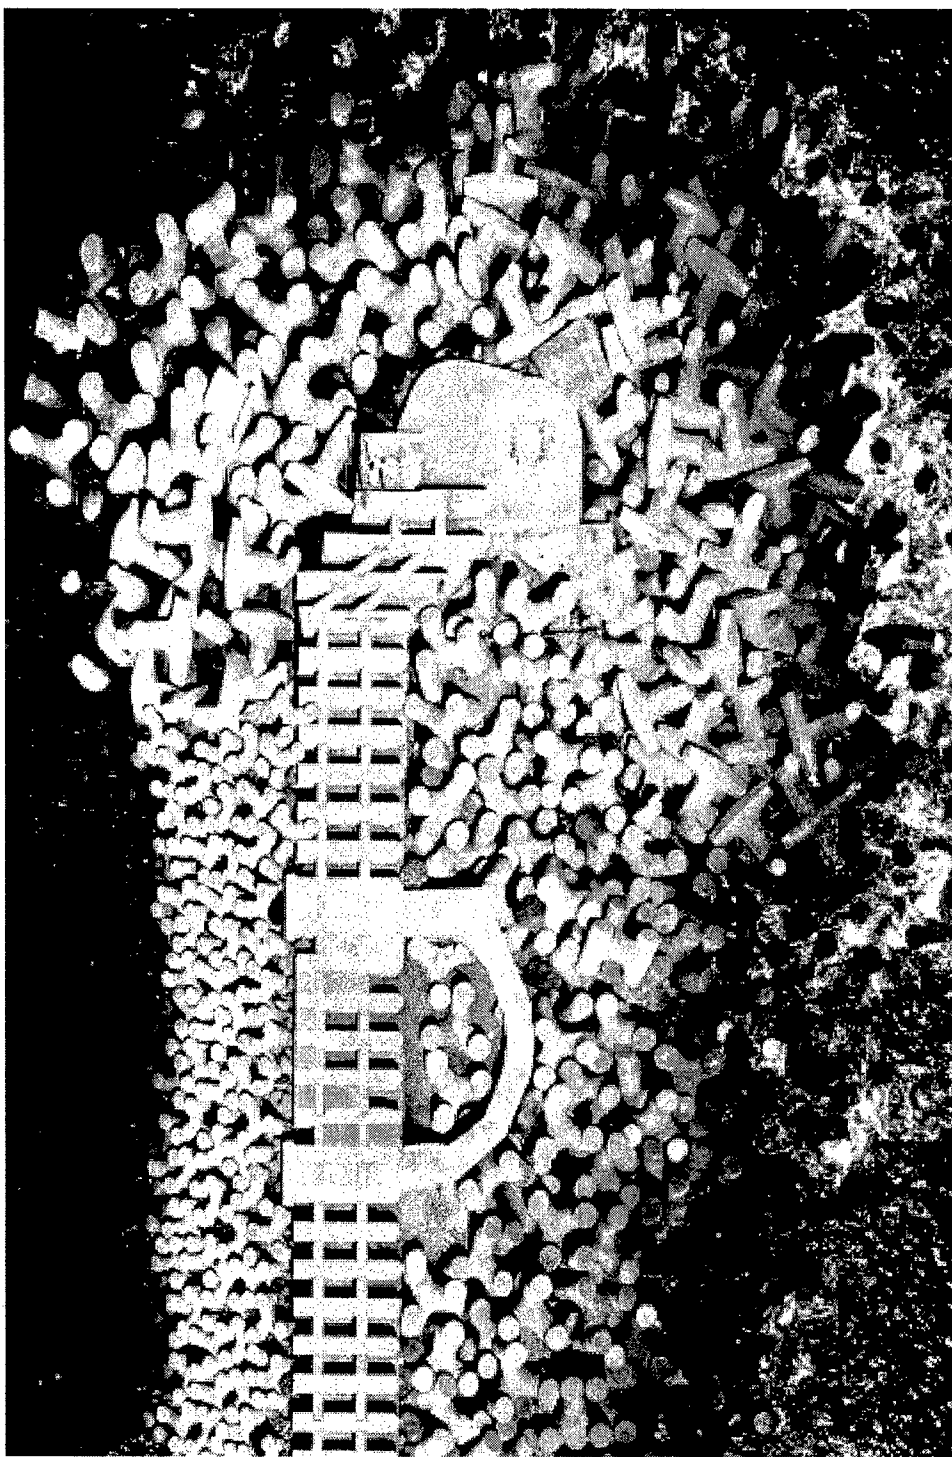
Photo maps combine the image characteristics of a photograph with the geometric qualities of a map. The image is rectified and free from skewness and distortion, and therefore, precise horizontal measurements may be obtained using an engineer scale. Photo maps were prepared for the outer portions of the Kahului east and west breakwaters and the Laupahoehoe breakwater for the 2001 survey. They were produced on mylar sheets at a scale of 1:240. Examples of photo maps for the Kahului east and west breakwater heads and the Laupahoehoe breakwater are shown in Figures 23-25. In an effort to quantify horizontal movement of nontargeted concrete armor units on the Kahului and Laupahoehoe breakwaters, photo maps obtained for the 1992/1993 and 2001 were compared. Eight 27,215-kg (30-ton) dolosse around the seaward quadrant of the head of the Kahului east breakwater (including targeted units KED and KEE) appeared to have slightly changed positions. Movement appeared to be on the order of 0.3 to 0.9 m (1 to 3 ft). These units have not broken and are considered functional. Just a few additional units on the remaining portion of the Kahului east breakwater, as well as on the Kahului west breakwater, had moved slightly with no concentrations in any specific areas. Negligible movement of nontargeted units on the Laupahoehoe breakwater was detected between the surveys.

Figure 23. Photo map of head of Kahului east breakwater

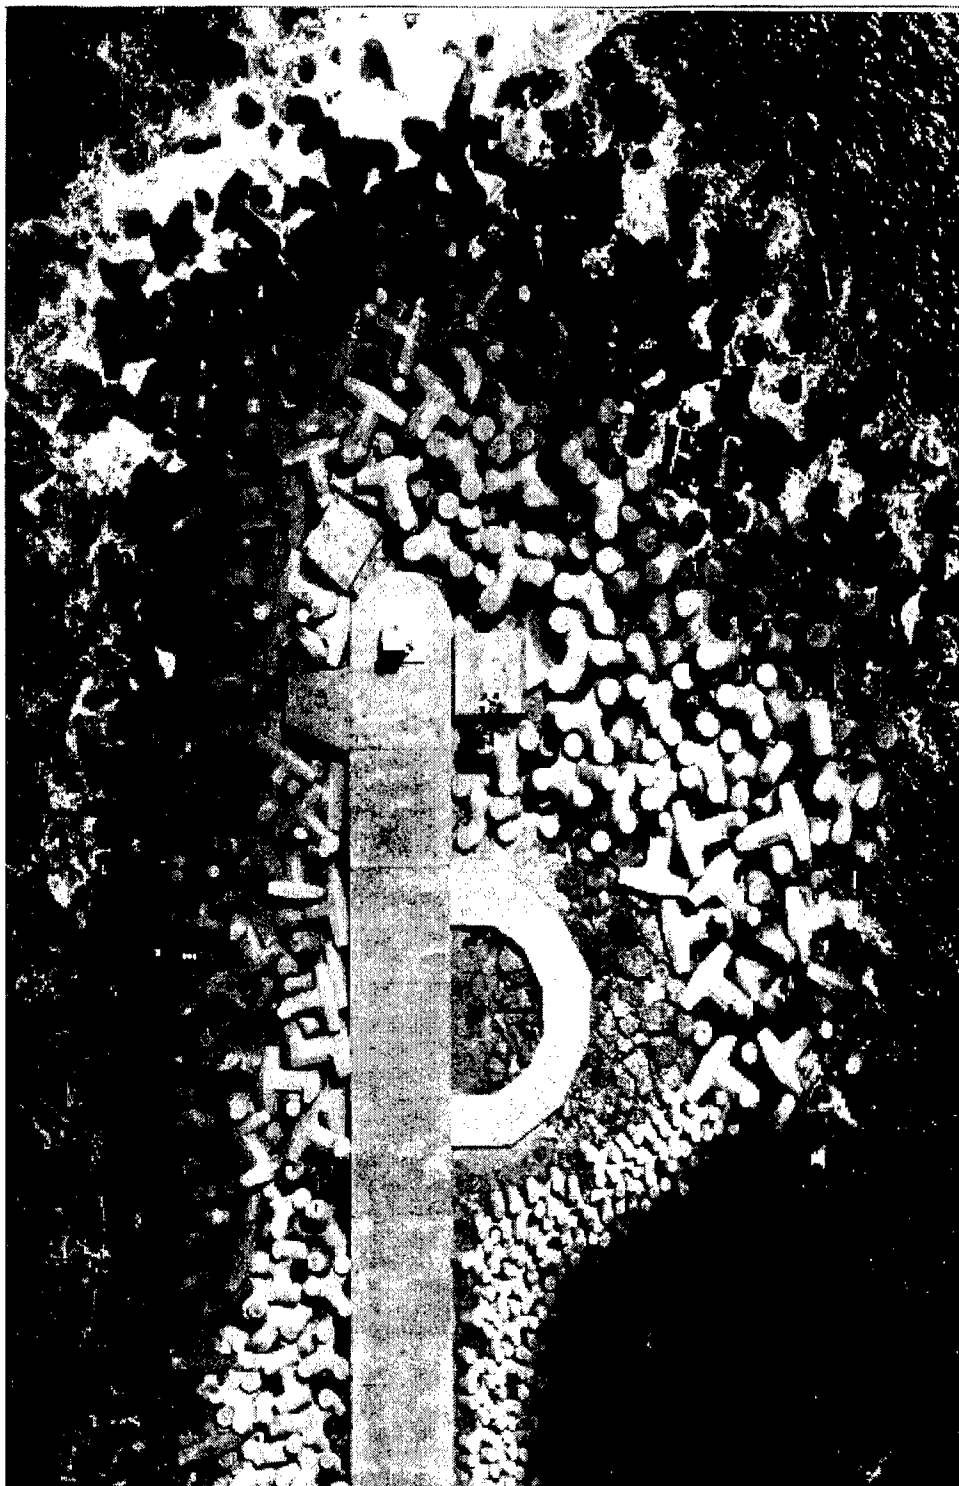
Figure 24. Photo map of head of Kahului west breakwater

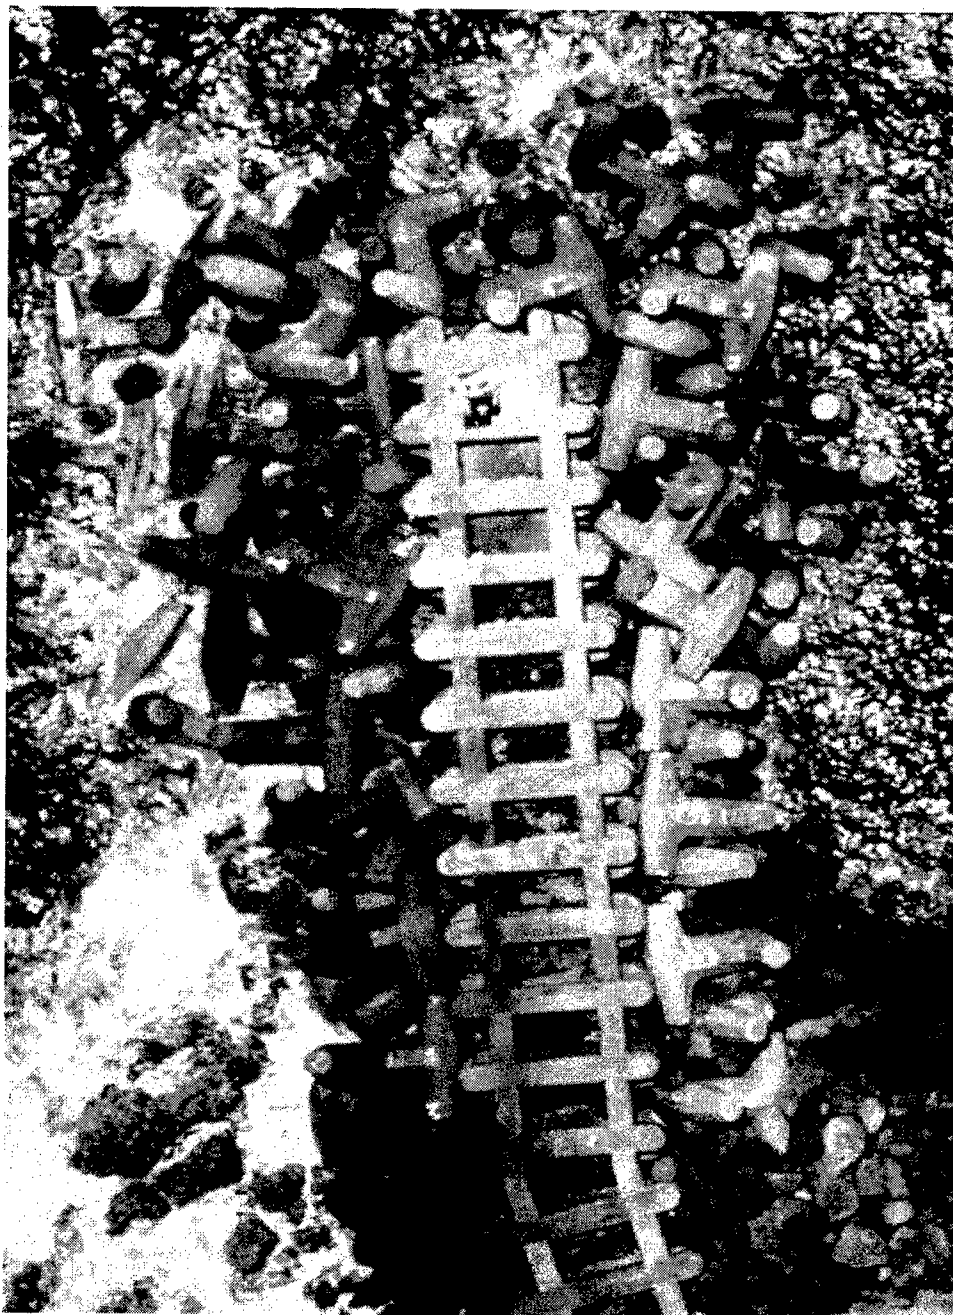
Figure 25. Photo map of Laupahoehoe breakwater

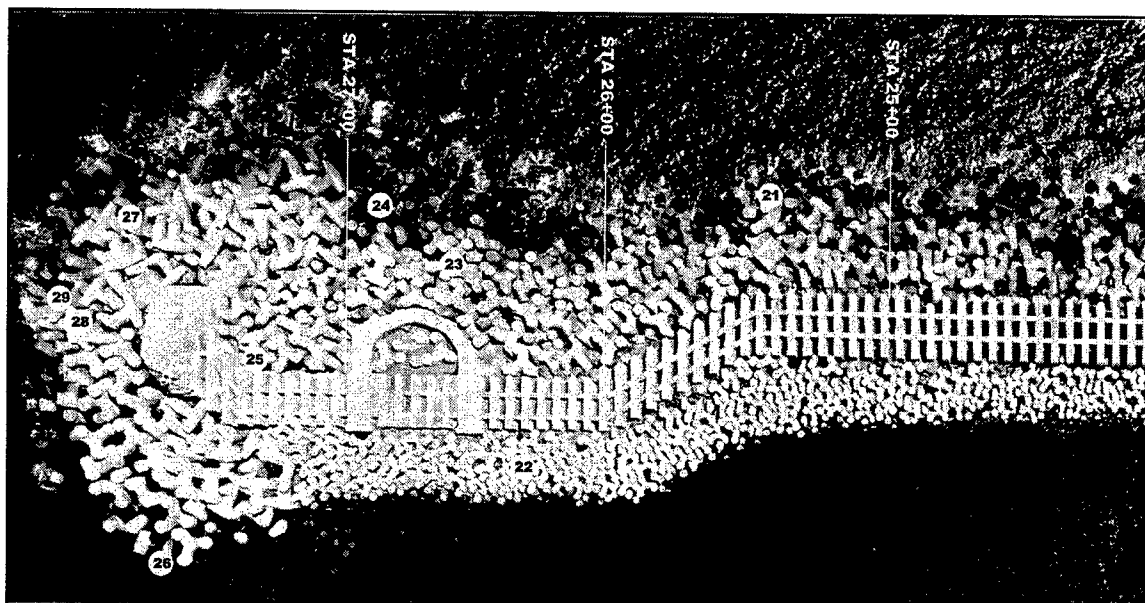
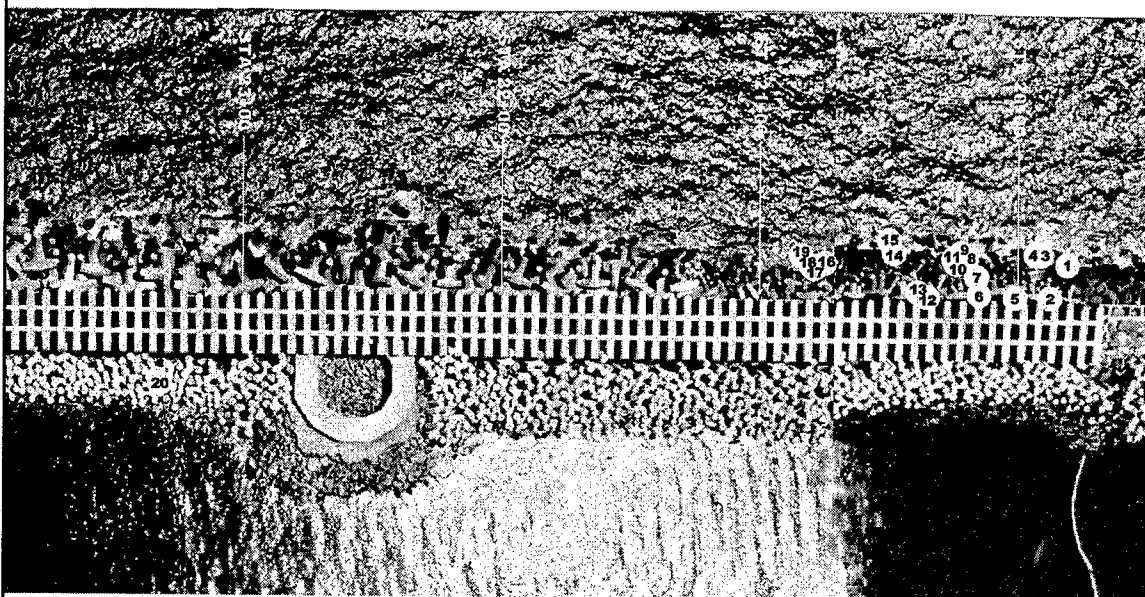
29 broken or cracked armor units were identified and 58 were observed on the Kahului west breakwater during the walking survey. No broken or cracked armor units were found on the Laupahoehoe breakwater.

The approximate locations of broken/cracked armor units along the Kahului east and west breakwaters are shown in Figures 26 and 27, respectively, and detailed data obtained during the broken armor unit inventory are shown in Table 11. Armor unit numbers identified in Figures 26 and 27 correspond to those listed in Table 11. Of the 29 broken armor units on the Kahului east breakwater, 19 were 5,445-kg (6-ton) dolosse; two were 8,165-kg (9-ton) tribars; four were 27,215-kg (30-ton) dolosse; and four were 31,750-kg (35-ton) tribars. The majority of the broken units (66 percent) were 5,445-kg (6-ton) dolosse located on the seaward side of the inner half of the concrete-armored portion of the structure. These broken units were concentrated between stas 19+60 and 20+84. Seventy-four percent of the broken 5,445-kg (6-ton) dolosse were located on the lower portion of the seaward slope in the active wave zone. Most the remaining broken units on the east breakwater were sporadically located around the head of the structure with no specific concentrations. Of the 58 broken armor units on the Kahului west breakwater, four were 5,900-kg (6.5-ton) tribars; one was a 9,980-kg (11-ton) tribar; 16 were 17,235-kg (19-ton) tribars; 18 were 18,145-kg (20-ton) dolosse; 11 were 27,215-kg (30-ton) dolosse; five were 29,940-kg (33-ton) tetrapods; and three were 31,750-kg (35-ton) tribars. On the west breakwater, 90 percent of the broken units were located on the seaward side of the outer half of the concrete-armored section of the breakwater. Concentrations of broken units occurred on the sea side of the breakwater between stas 20+50 and 21+50 and stas 22+50 and 23+50. Most broken units (66 percent) also were located on the lower portion of the seaward breakwater slope in the active wave zone.

Figure 26. Approximate locations of broken/cracked armor units along outer portion of Kahului east breakwater

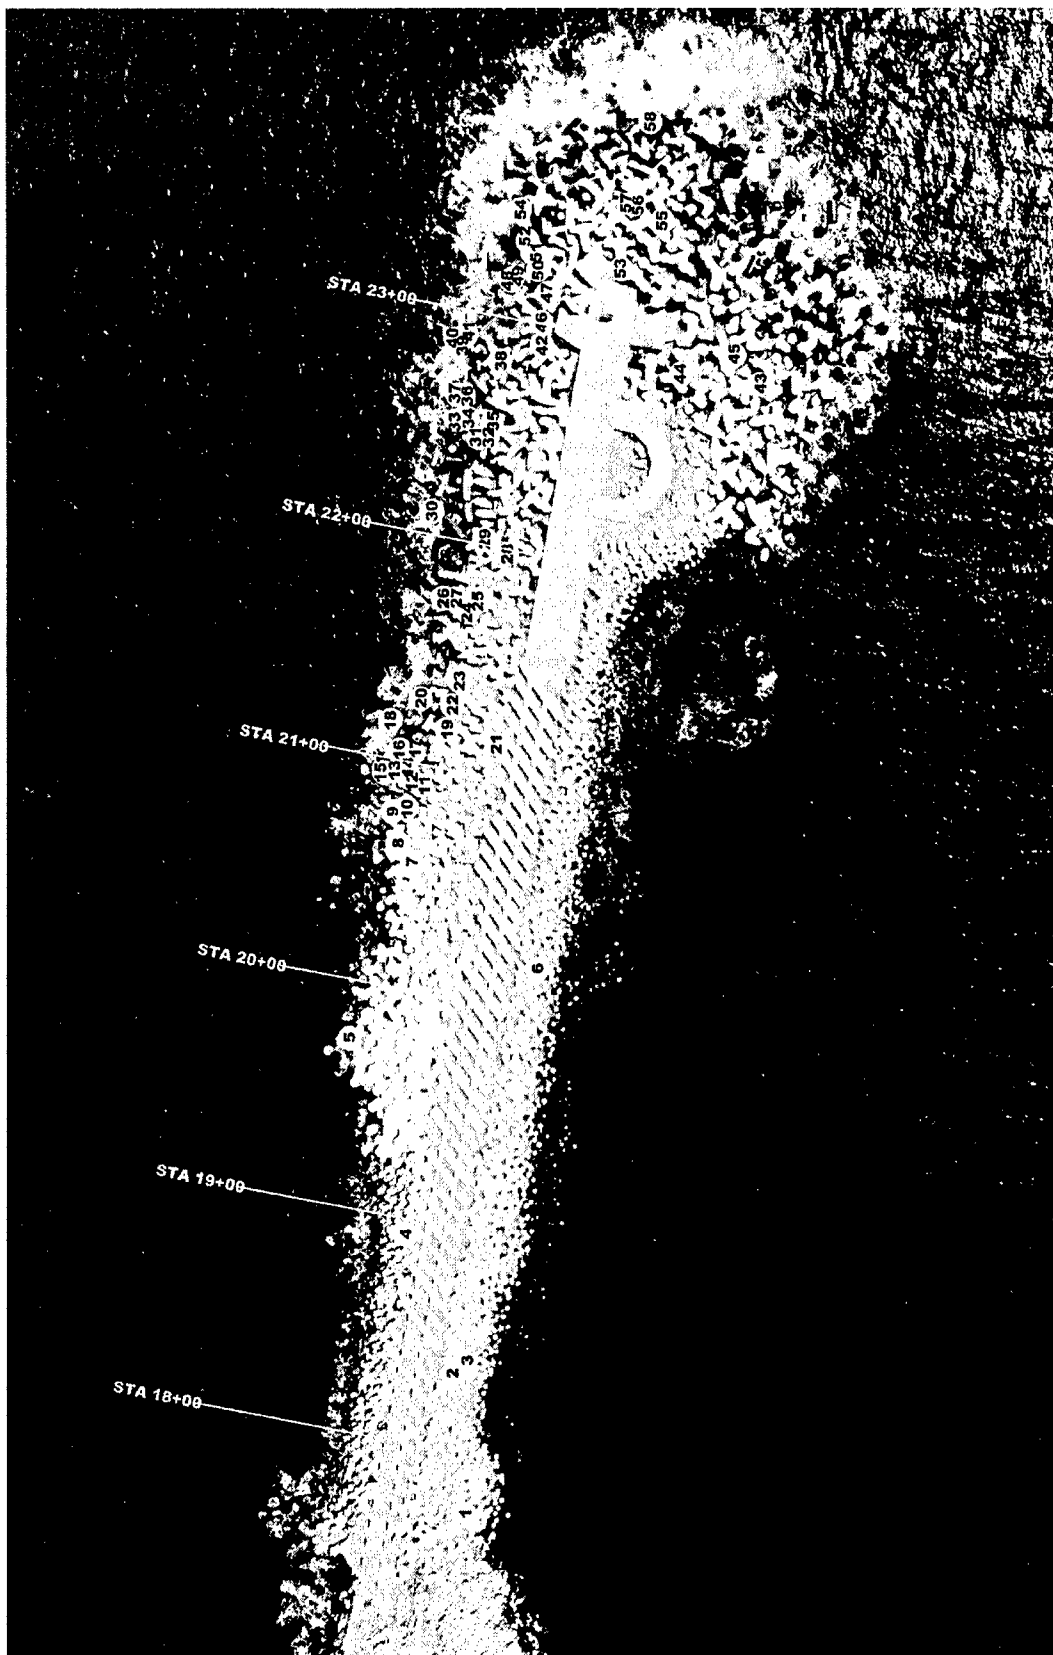
Figure 27. Approximate locations of broken/cracked armor units along outer portion of Kahului west breakwater

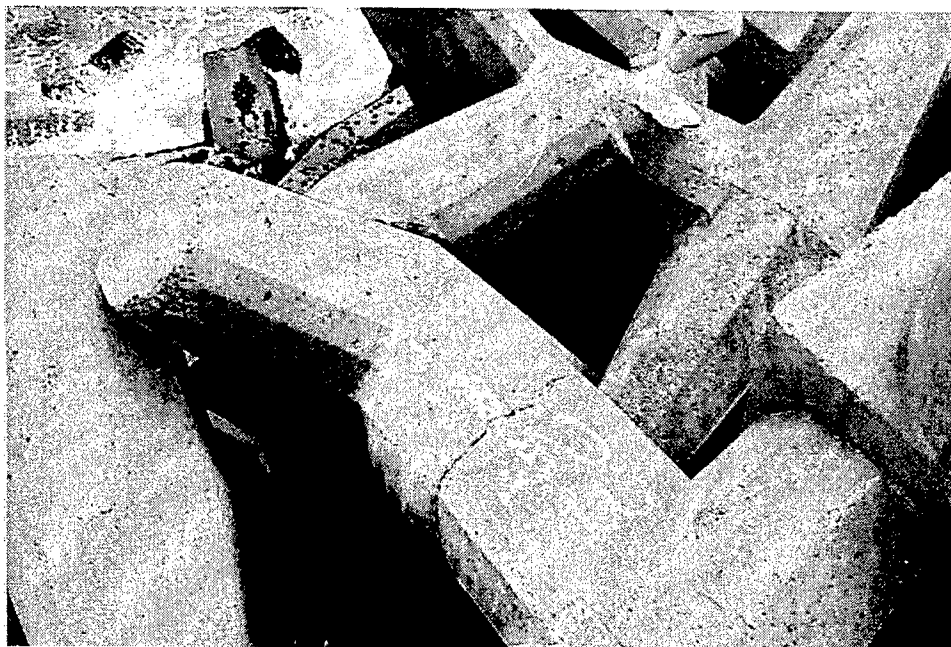
Views of representative types of breaks for the armor units are shown in Figures 28-31. Armor units with hairline cracks on one side were not counted, only those that were cracked all the way through were considered a break for recording purposes.

Figure 28. Dolos with mid-shank crack

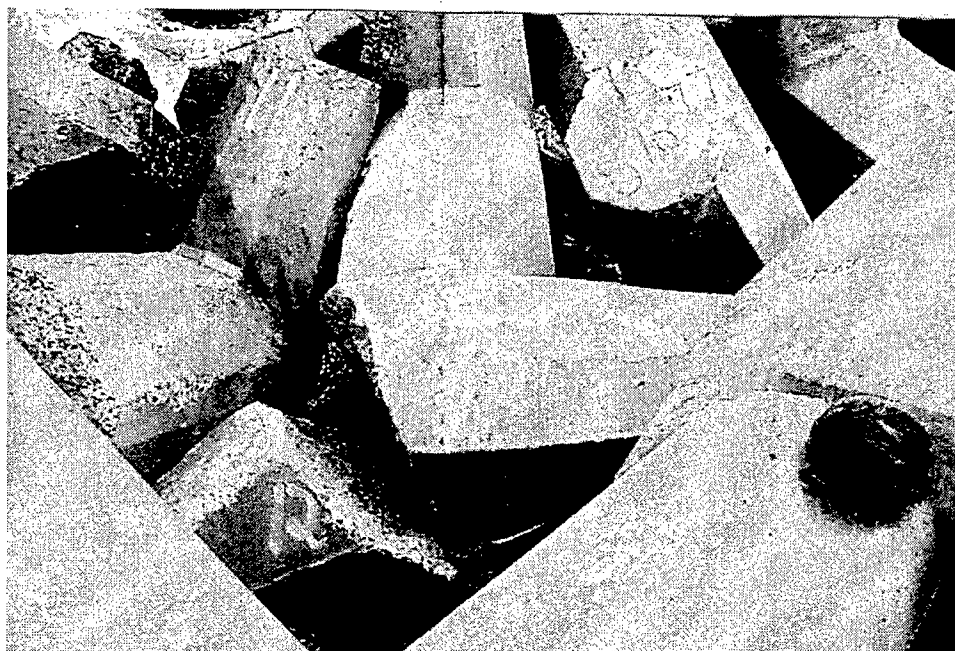
Types of breaks for the dolosse included shank and fluke breaks. These were characterized as mid-shank, shank-fluke (shank broken in vicinity of fluke), and fluke-shank (fluke broken off at junction with shank). Also recorded were straight breaks (broken straight across) and angled breaks (broken at some angle to the dolos limb). For the tribars and tetrapods, types of breaks included those through the center section of the unit where one or more legs were separated from the unit, and those in which just a portion of one of the legs was broken off.

Figure 29. Dolos with fluke-shank break

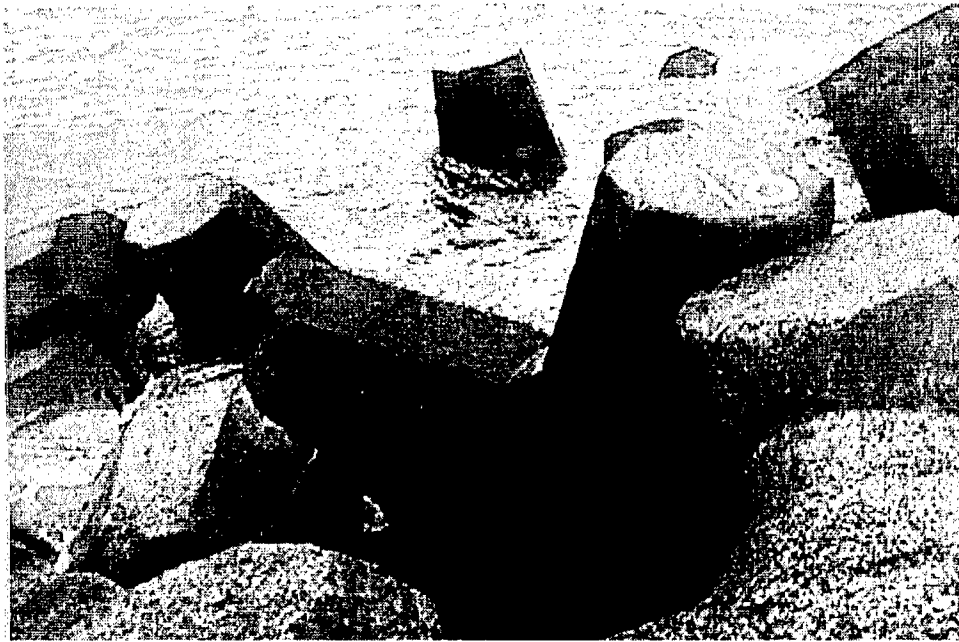
Considering the types of breaks for the 52 broken dolosse on both the Kahului structures, 75 percent had shank-fluke breaks, 16 percent had fluke-shank breaks, and 9 percent had mid-shank breaks. Of the dolosse breaks recorded, 78 percent were straight and 22 percent were angled. Considering the types of breaks for the 35 tribars and tetrapods on the Kahului breakwaters, 89 percent included units with breaks through the center sections where one or more legs had separated, and 11 percent had just portions of a leg broken off the unit.

Figure 30. Dolos with shank-fluke break

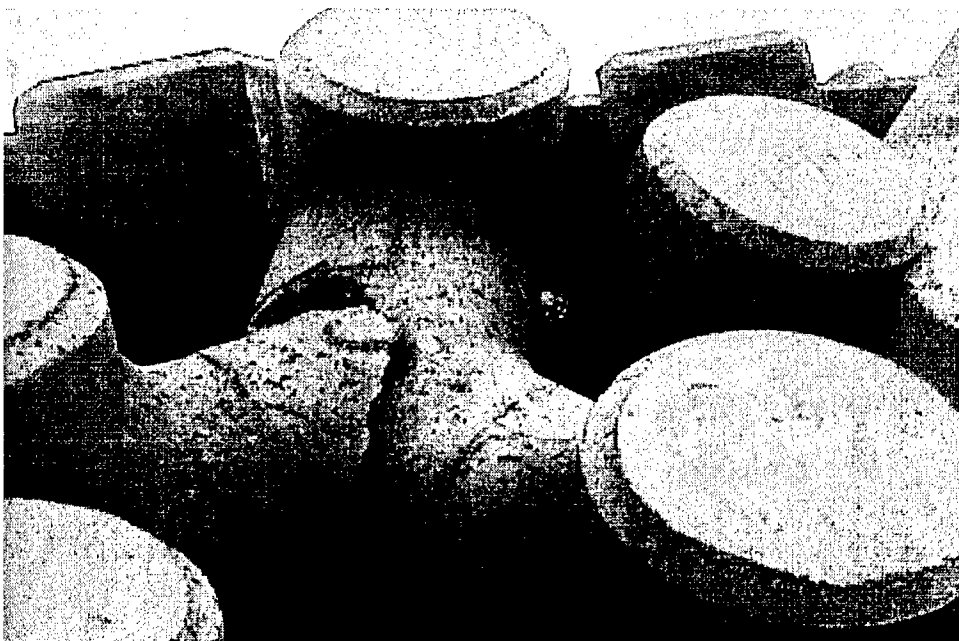
Figure 31. Tribar with break through center section of unit
